SPECIAL AIRWORTHINESS INFORMATION BULLETIN

No. CE-01-11
February 7, 2001

This Special Airworthiness Information Bulletin (SAIB) informs you, an owner or operator of British Aerospace Jetstream 3100 and 3200 series aircraft that British Aerospace (BAE SYSTEMS) has issued Service Bulletin (SB) 11-JK12175 to change the label (placard) on the baggage bay bulkhead to properly identify the fire extinguisher inlet.

TITLE: PLACARDS AND MARKINGS - INTRODUCTION OF FIRE EXTINGUISHER INLET LABEL TO BAGGAGE BAY BULKHEAD IN REAR VESTIBULE AREA

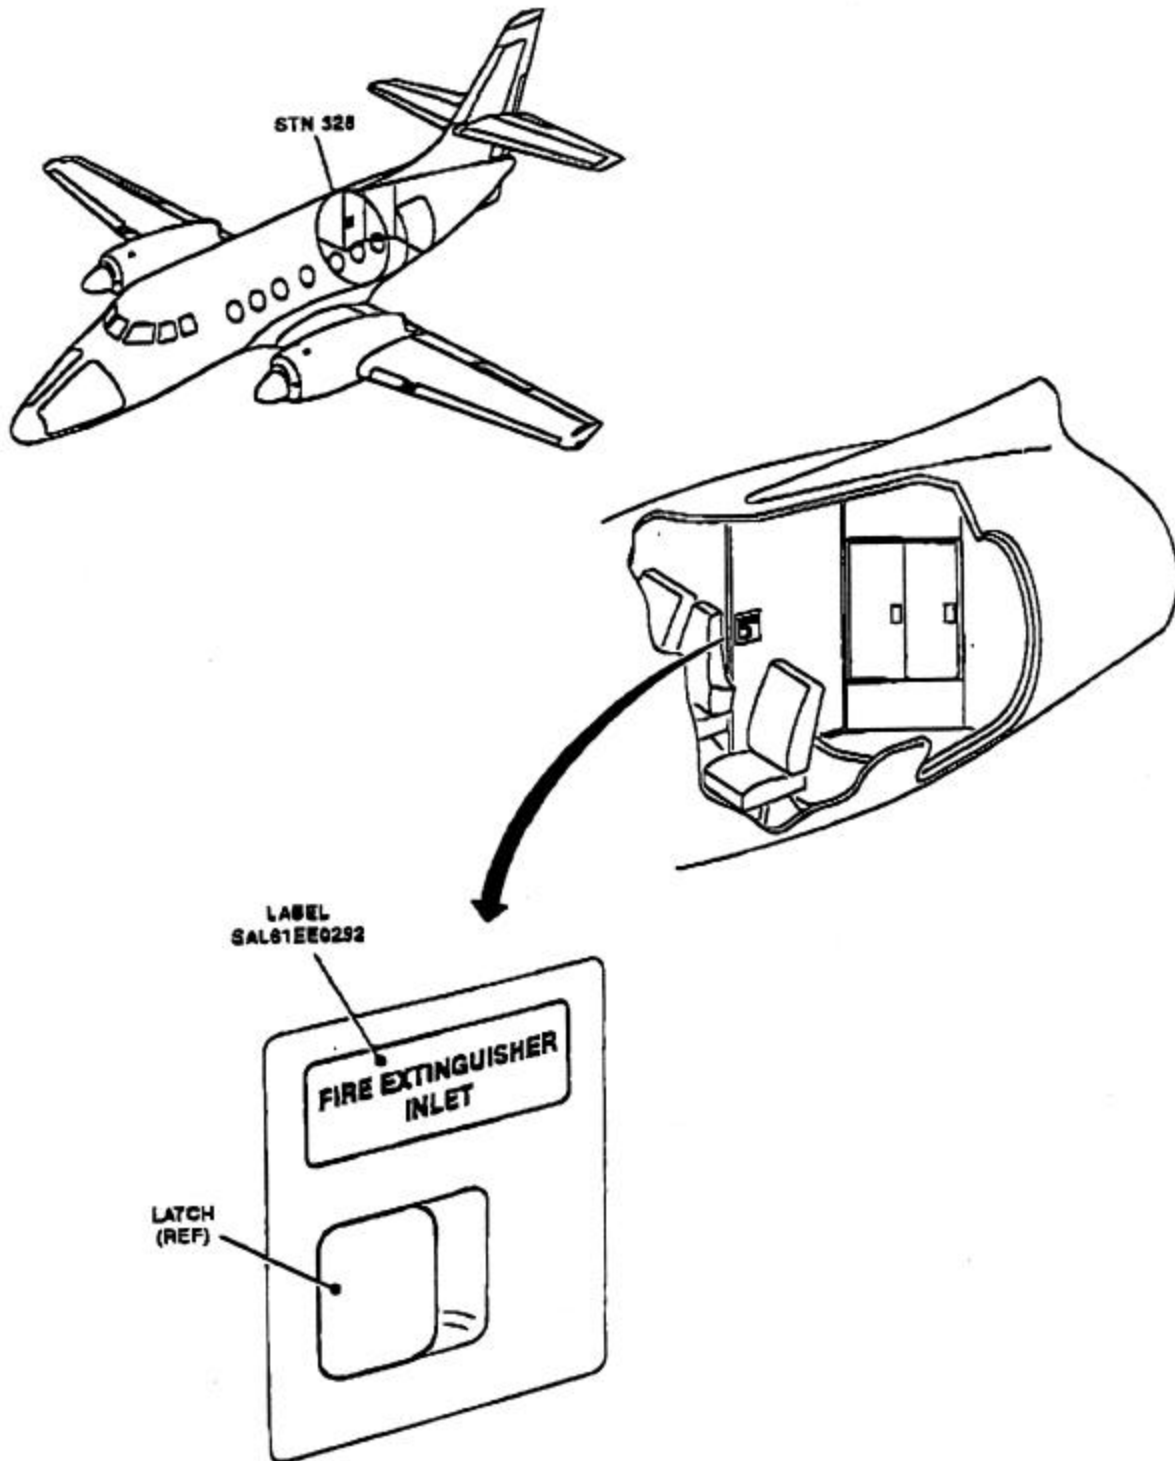
POSITIONING OF THE NEW LABEL
FIGURE 1

This SAIB is the corrective action of FAA safety recommendations 00.045, 00.046 and 00.047. During a ramp inspection, the FAA Flight Standards District Office (FSDO) inspectors discovered that an incorrect placard was installed directly above an access panel on the forward section of the aft interior baggage compartment on numerous Jetstream 3201 model aircraft. The placard in question was worded: "FIRE FIGHTING ACCESS ONLY". At that time, the subject aircraft's Illustrated Parts Catalog (IPC) showed the wording of the placard **should be "FIRE EXTINGUISHER ACCESS ONLY"**. The FAA FSDO has concerns that the passengers could misconstrue the wording on both the correct and incorrect placards that the access door is where they would find the hand-held fire extinguisher. In reality, the access panel is only used as a port in case there is a fire in the baggage compartment and then the hand-held fire extinguisher would be inserted in the opening in order to dispense the extinguishing agent. During an emergency situation, there is the possibility that a passenger might try and open the access panel looking for a hand-held fire extinguisher, when in fact it is located elsewhere.

FAA Safety Recommendations 00.045 to 00.047B indicate that the existing fire extinguisher access label installed on the baggage bay bulkhead may be misinterpreted by passengers during an emergency that requires the discharge of an extinguisher into the baggage compartment.

- (1) Refer to SRM 51-00-00. Remove any existing associated labels on or around the access panel at the baggage bay bulkhead in the rear vestibule before installation of the new label.
- (2) Refer to Figure 1 and SRM 51-00-00. Clean the area shown for the attachment of the new self-adhesive label with an approved solvent.
- (3) Refer to Figure 1. The label SAL61EE0292 should be attached above the latch on the access panel at the baggage bay bulkhead in the rear vestibule in a convenient and easily viewed location.
- (4) Ensure all areas worked in are clean and free from dirt, tools and loose articles.
